上海贝尔TD- LTE无线网络优化及案例分析

2012-09

上海贝尔

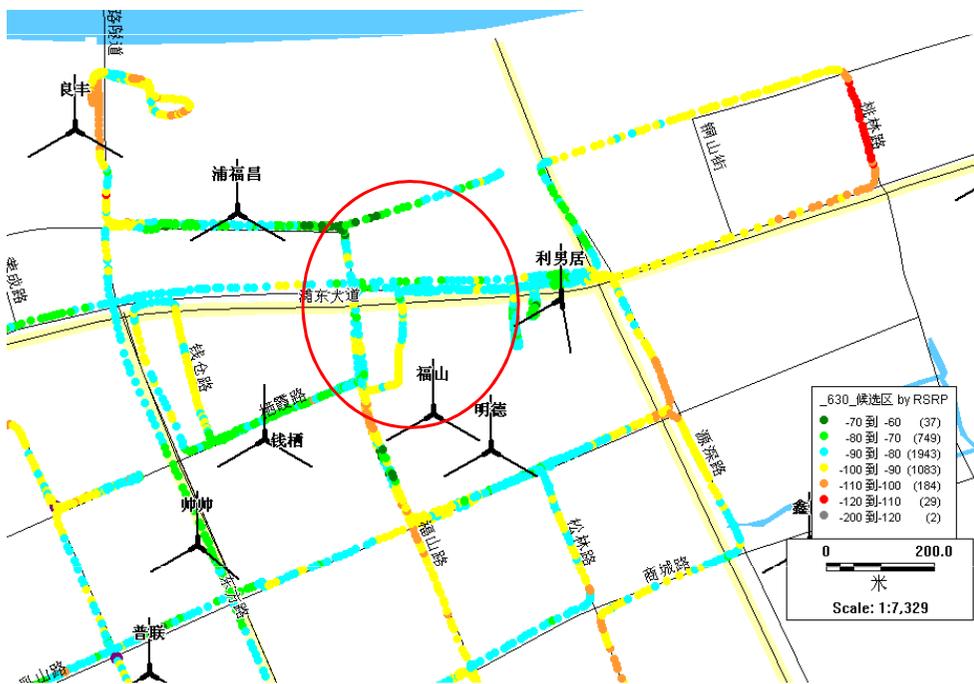
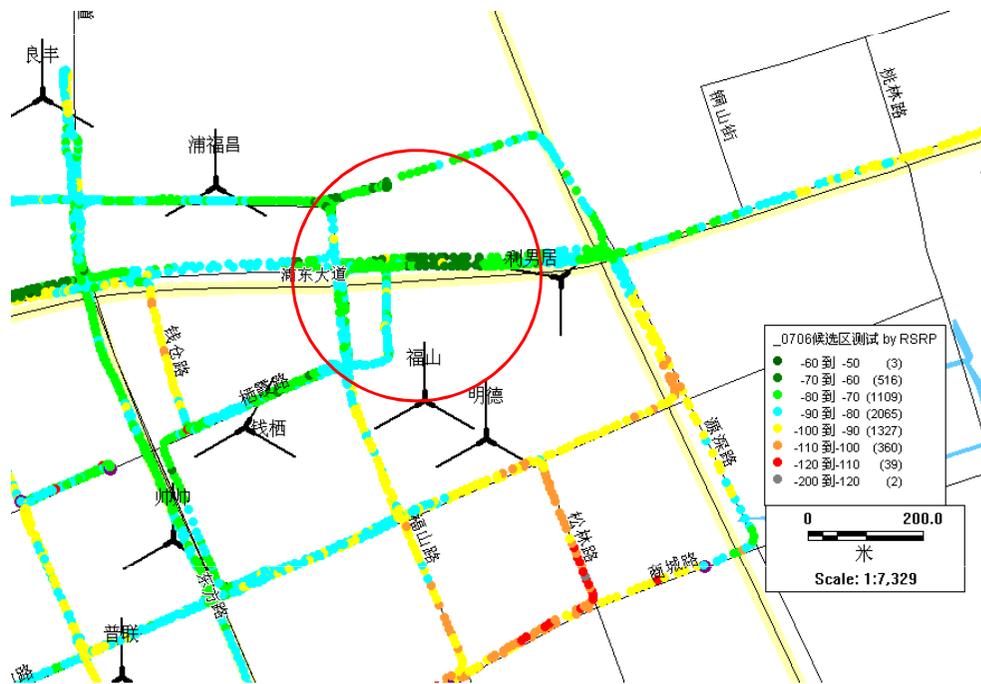
某区域优化前后RSRP覆盖图

- 根据路测结果分析最强小区，次强小区以及其他覆盖小区信号强度决定主服务小区
- 根据主服务小区适当减弱邻区对主服务小区的覆盖从而提高SINR的覆盖
- 调整方法：天线方位角，下倾角，功率控制参数

该区域属密集城区，周围有商务区，密集居民区，厂房以及学校等。先前以下站点周围有建筑物阻挡，影响覆盖，因此进行天线调整，结果如下：

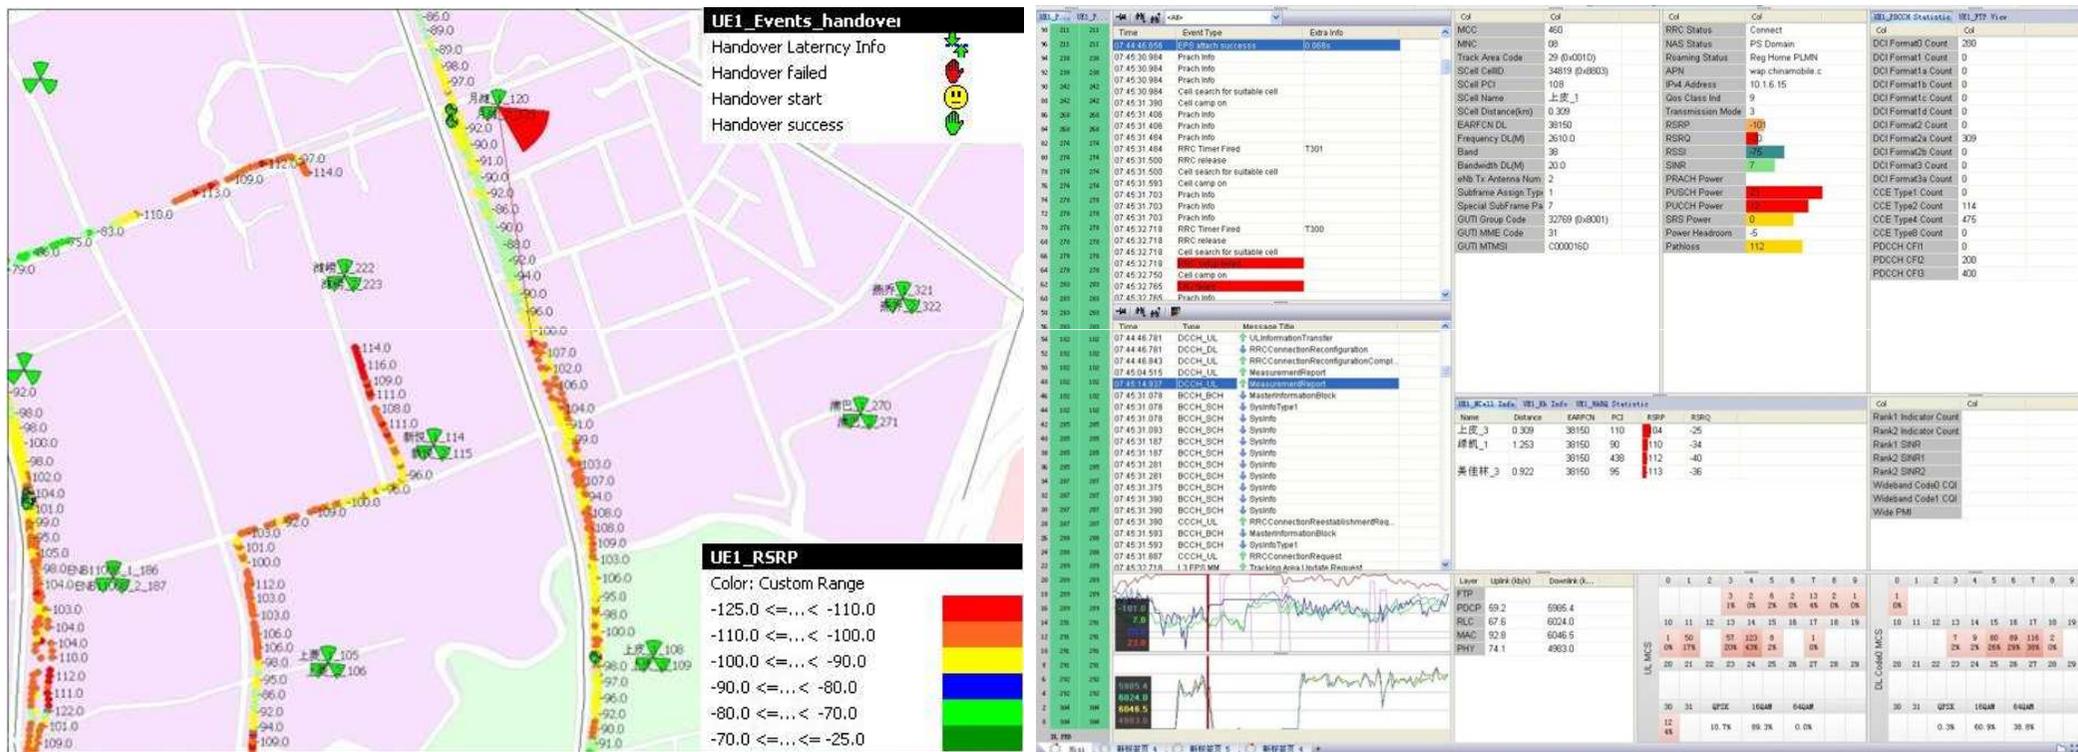
分析和优化措施 - 覆盖问题引起切换失败

信号（覆盖）问题
 测量上报（MR）问题
 切换带优化问题
 邻区关系问题

分析
 UE侧已连续发送2条MR，且PUSCH已达最大发射功率
 eNB的trace显示未收到相应测量消息
 小区121、108信号都较弱
 优化措施
 小区108下倾角调整
 小区121下倾角调整
 优化结果
 切换成功

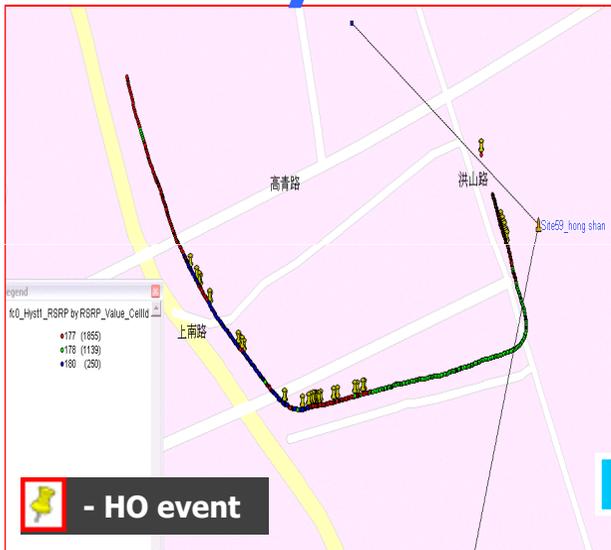
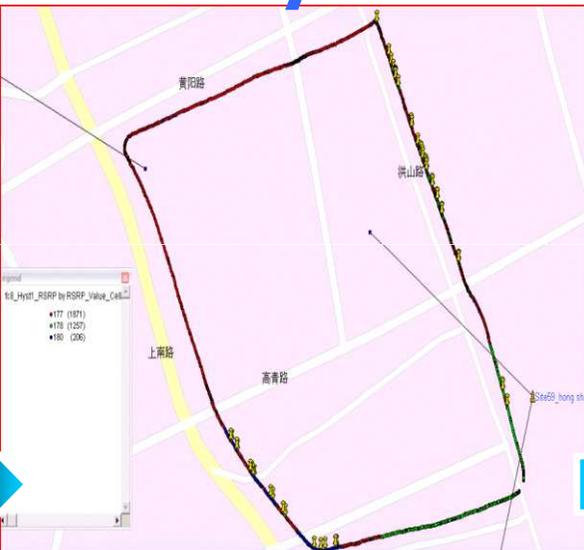
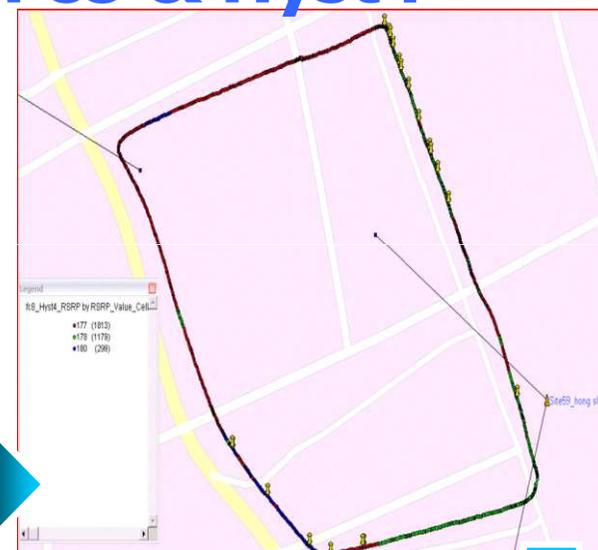
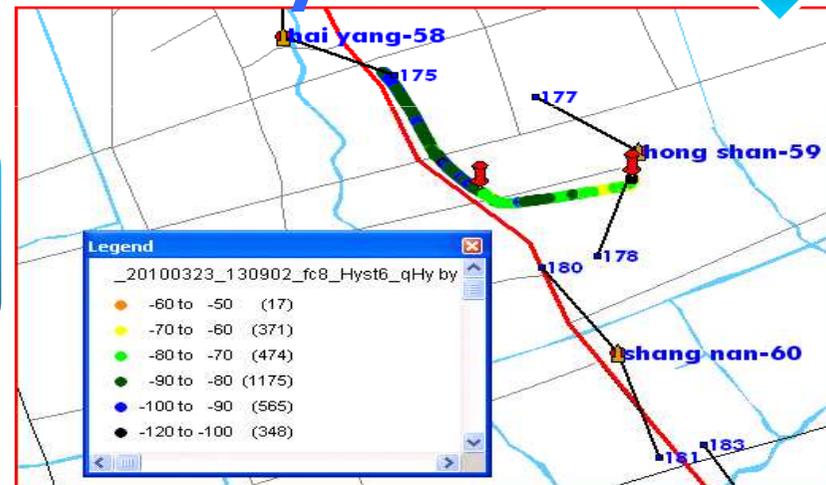
HO Ping-Pong reduced by using fc8&Hyst6

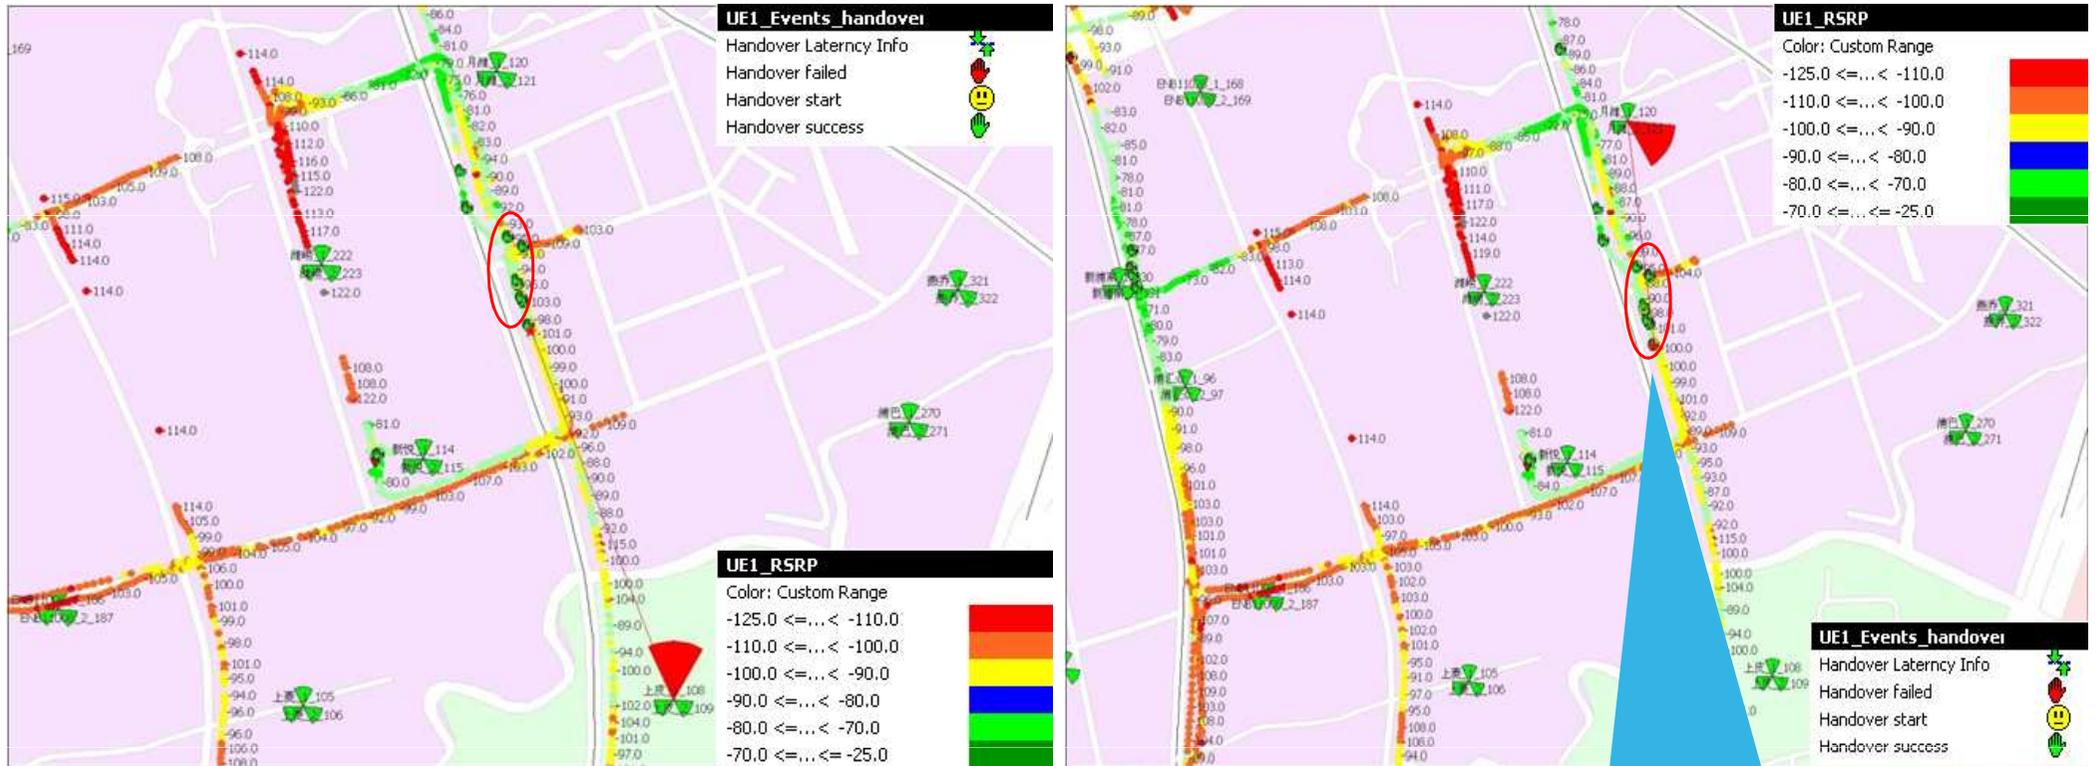
分析和优化措施 - Pingpang切换

分析
小区108、121间存在Pingpong切换
优化措施
EventA3 offset从1dB增加到2dB
Hysteresis从2dB增加到3dB
触发时间由100ms设为256ms

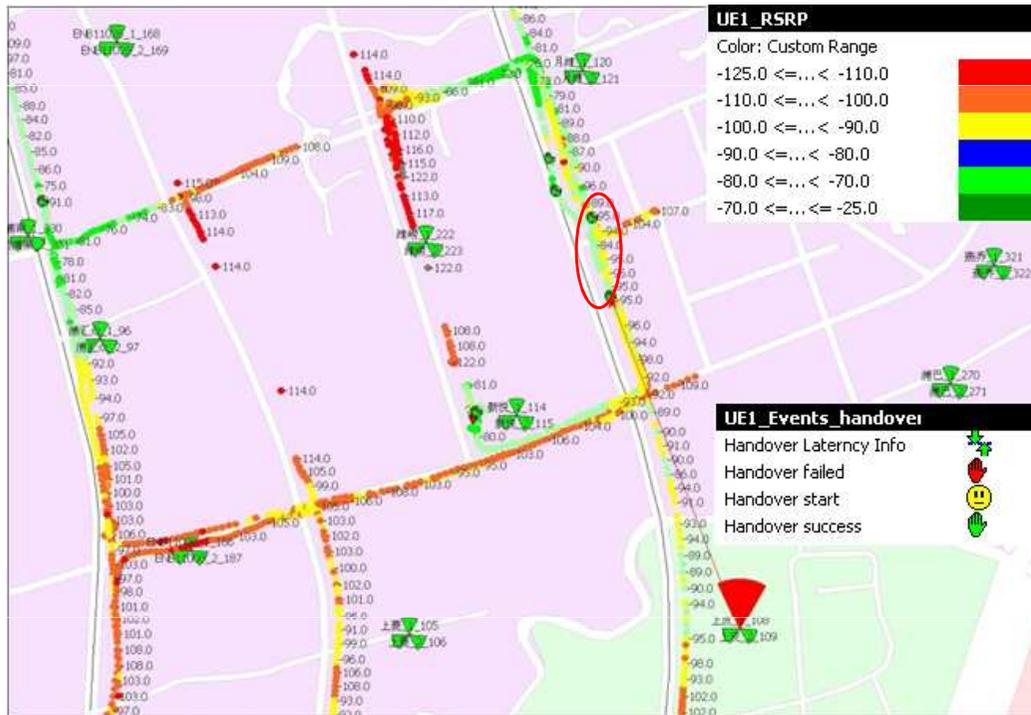
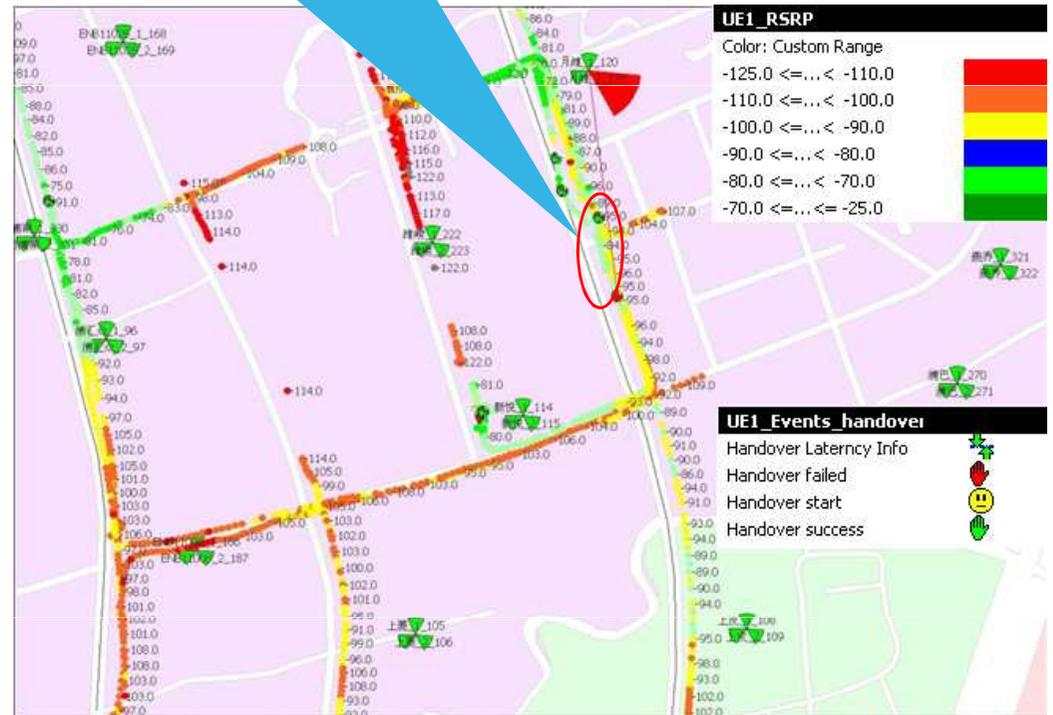
优化结果

Ping-pong切换已消除，切换更平稳

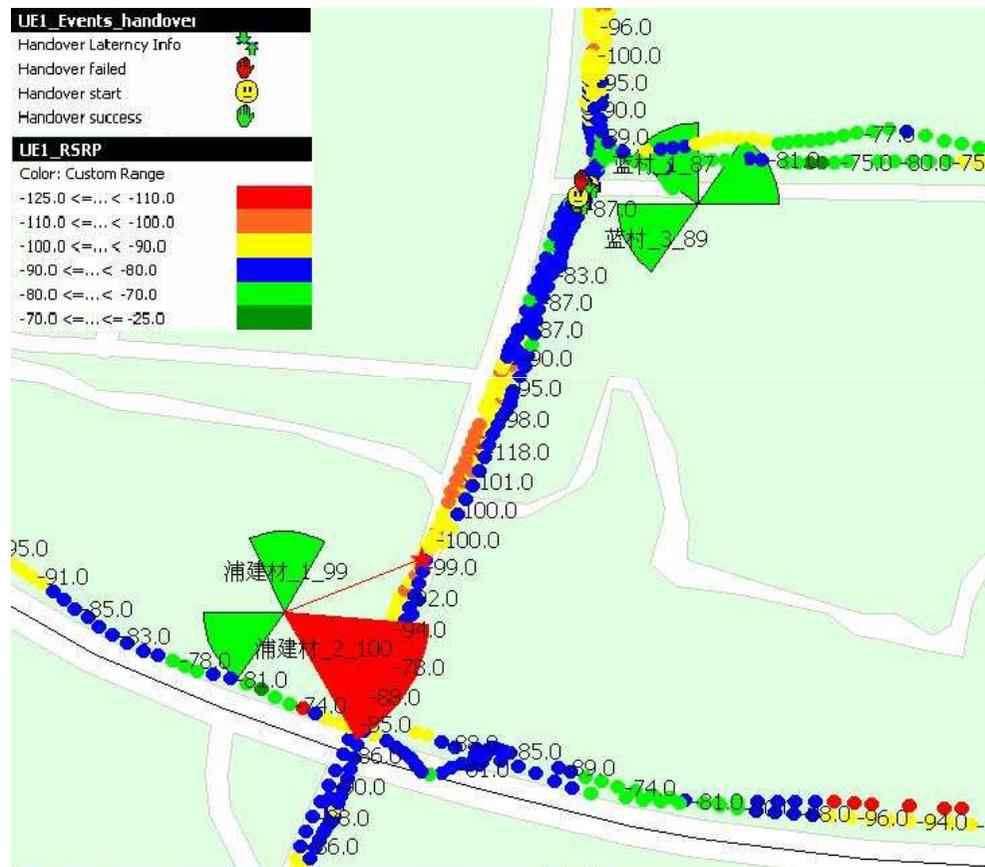
未收到eNB下发measConfig

现象
 目标小区已满足MR触发条件，但UE不发MR，UE在源小区挂死，不切往目标小区，并使RSRP比实际信号差。

分析
 UE侧未收到任何eNB下发的Intra/Inter Frequency的测量配置消息
 源小区PCI 100信号已较弱，但UE不测量邻区导致无法切换。
 排查邻区关系和测量配置发现并无问题，怀疑eNB侧切换开关未开启

优化措施
eNB侧Intra/Inter Frequency
mobility开启
优化结果
UE可收到measConfig, 有
Measurement Report, 切换正
常; 信号覆盖也变得正常。

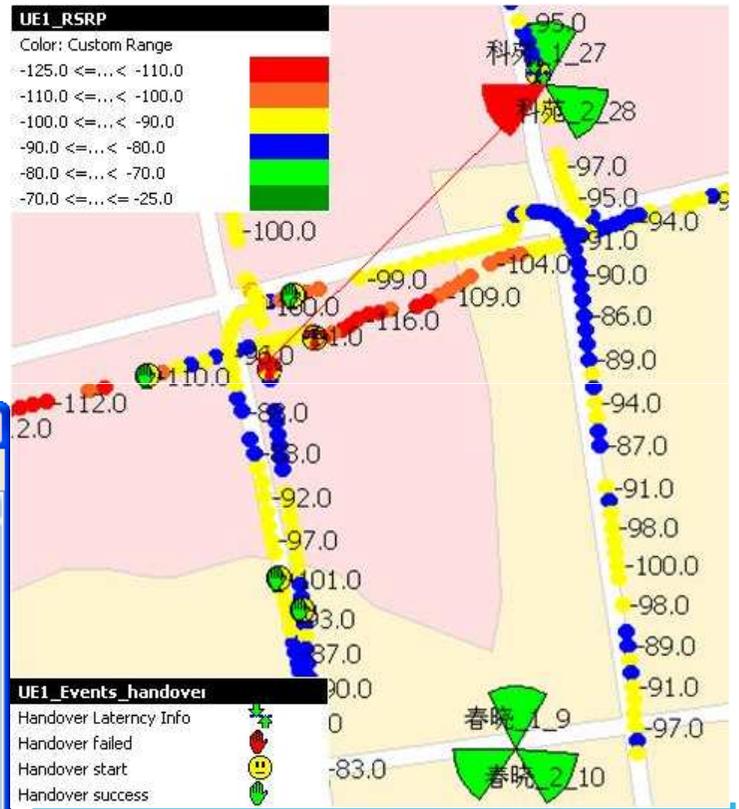
已收到eNB下发 measConfig

measConfig中测量频点错误配成了 38050

现象
 UE测不到任何邻区，始终不发MR，挂死在源小区，并使RSRP比实际信号差。

分析
 UE侧已收到eNB下发的Intra/Inter Frequency的测量配置消息
 源小区PCI 29信号已较弱，但UE测不到任何邻区导致无法切换。
 排查切换开关和邻区关系并无问题，怀疑UE测量配置存在问题。
 检查发现measConfig中测量频点错误配置成了38050，而不是当时全网的37900。

优化措施
 修改UE测量配置中的测量频点dIEARFCN为全网当前的37900
优化结果
 UE上报Measurement Report, 由小区29切换至小区10; 信号覆盖也变得正常。

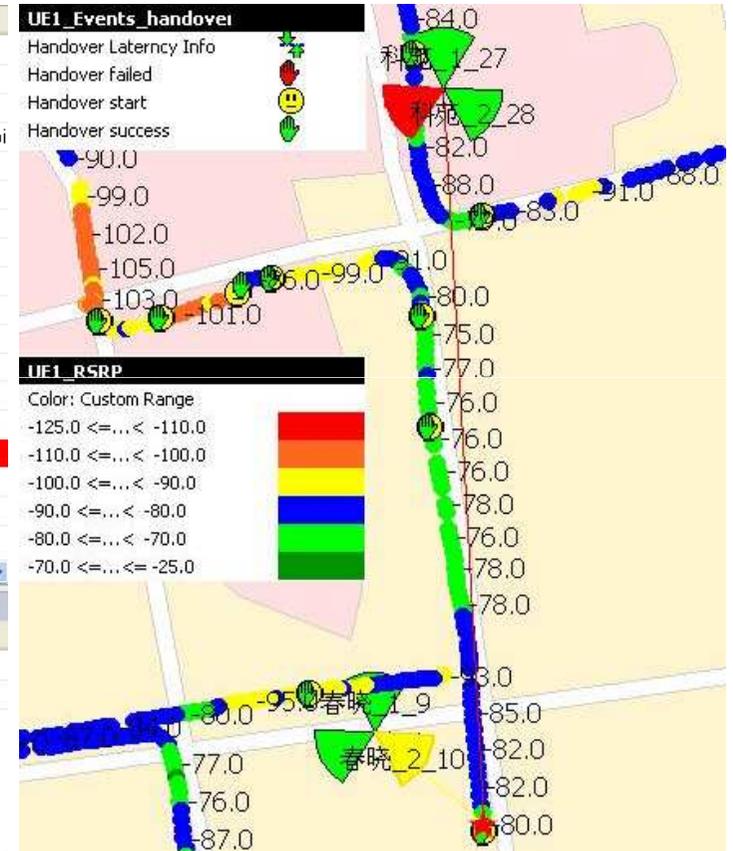
UE由小区29成功切换至小区10

eNB下发的measConfig中, 测量频点修改为全网使用的37900

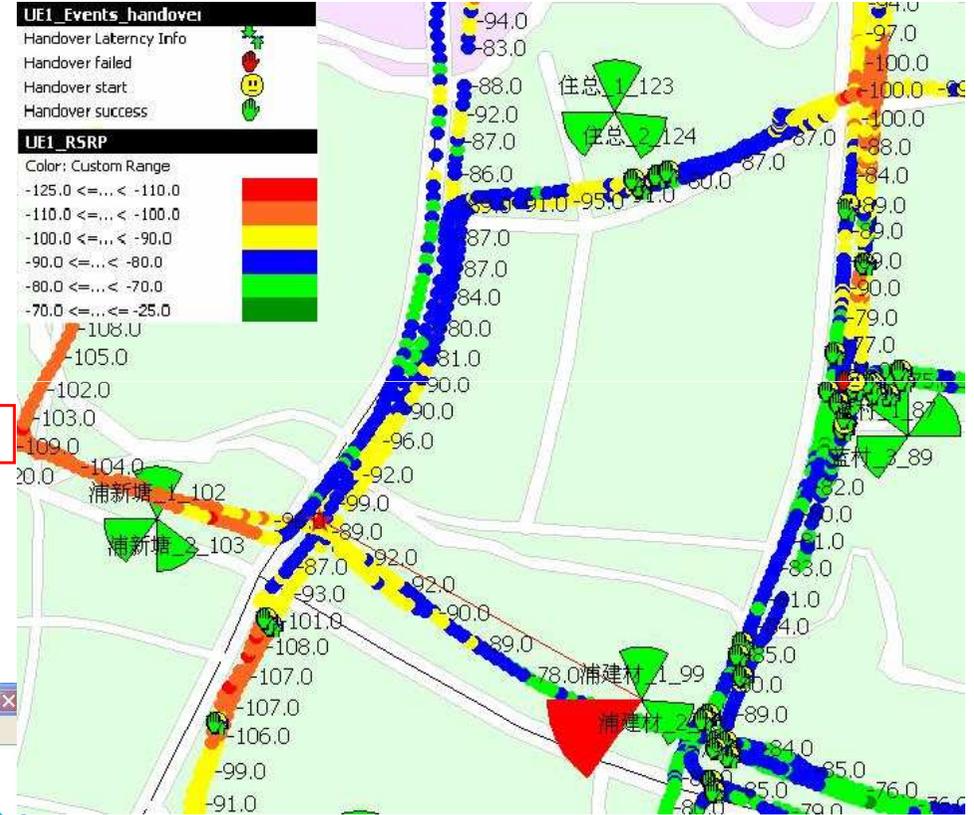
UE上报多条MR, 仍未切

源小区 measConfig 未配置目标小区作为邻区

现象
源小区到目标小区的MR已上报, 但仍不触发切换。

分析
单用户接入, 已排除RAC原因; 检查测量相关配置和切换开关未发现问题, 怀疑是邻区关系未正确添加。查看源小区measConfig, 发现确实未配置UE上报的目标小区的邻区关系。

优化措施
添加相应邻区关系

优化结果
切换正常。

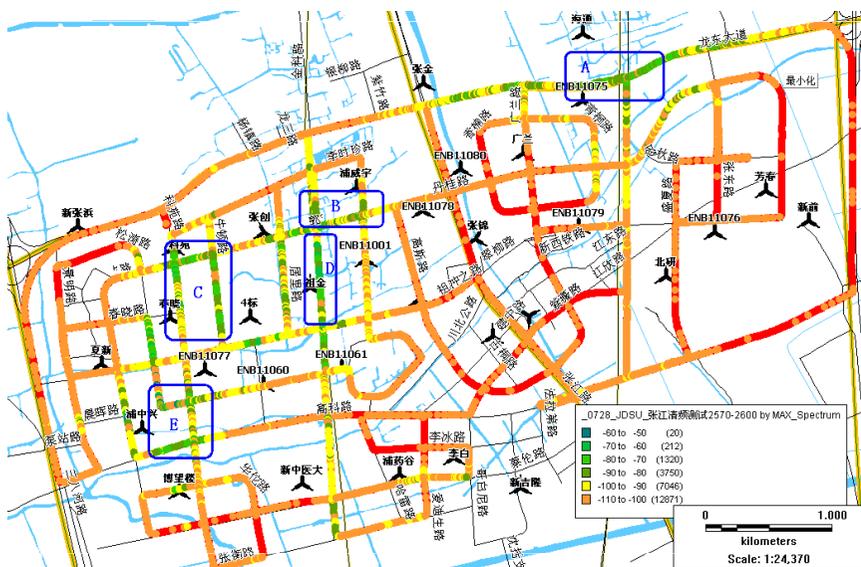
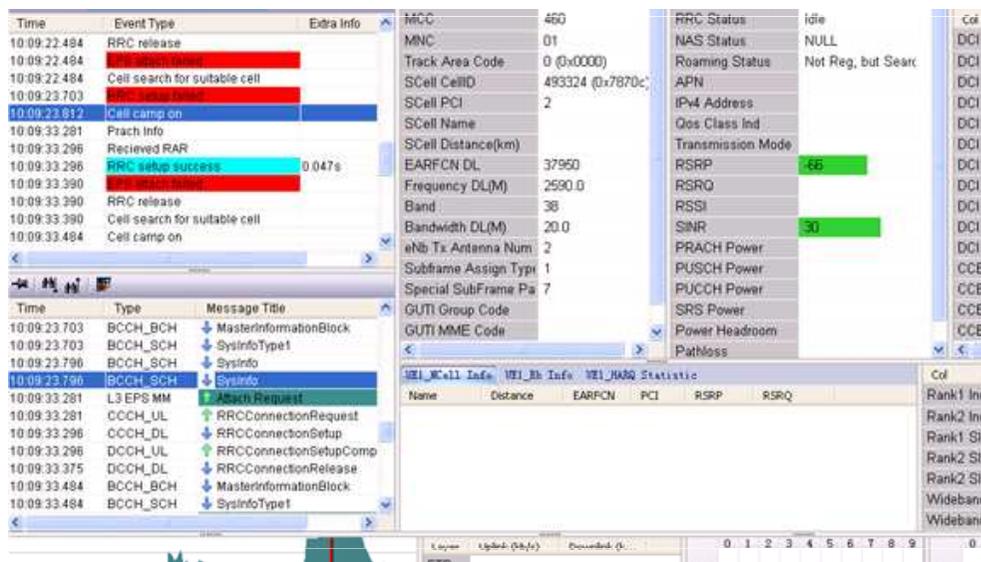
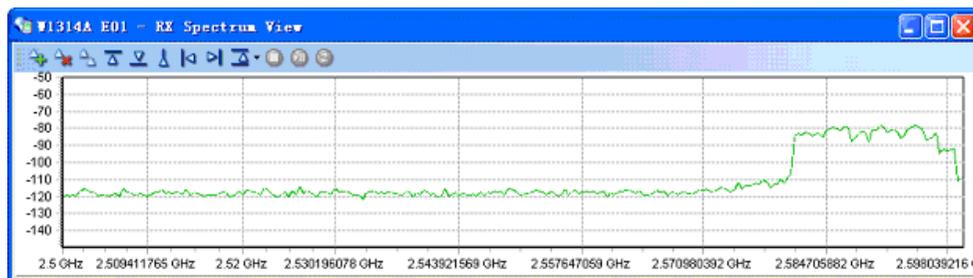
一发现在张江测试区某站信号**RSRP**和**SNR**比前期测试时低，并且业务信道**BLER**很高，导致在某站无法接入，影响**LTE**网络性能和测试进程。怀疑有干扰。

一关闭测试区域所有基站，进行扫频测试（**2570MHz-2600MHz**），发现张江主测区域遭受某厂商**LTE**信号强干扰，追踪到得信号频点为**2.59G（37950）**，带宽为**20MHz**的干扰信号。最高的干扰到达**RSRP：-66**，**SNR：30**

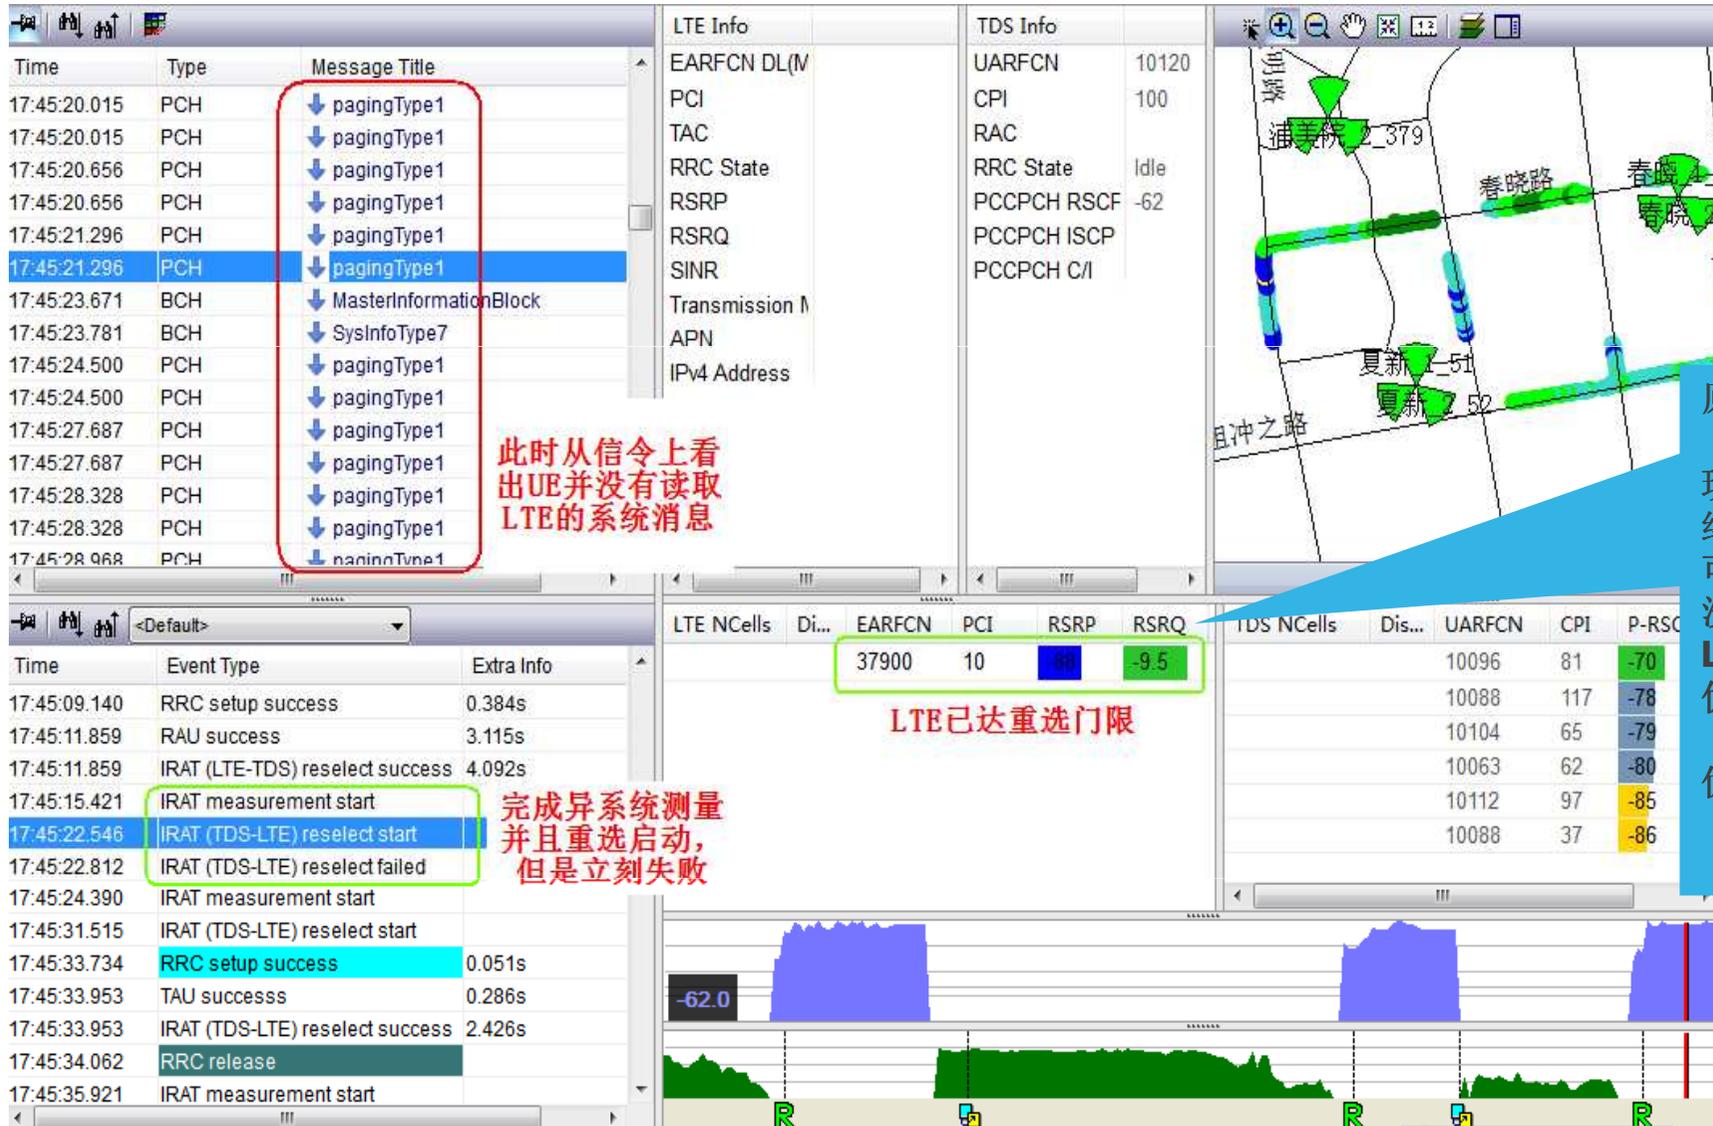
UE问题导致重选失败

此时从信令上看
出UE并没有读取
LTE的系统消息

LTE已达重选门限

完成异系统测量
并且重选启动,
但是立刻失败

原因分析
UE在TDS网络测量发现已经满足重选到LTE网络条件, 并且启动了重选, 可是重选到LTE网络后却没有发现LTE小区或者LTE小区不满足驻留条件

优化措施
升级UE版本

优化结果
重选正常进行
